RE: Baruch College - Site "B"
Contract #16 - GC #2
Epoxy Terrazzo - Uplift/Debonding

PRELIMINARY SITE INVESTIGATION REPORT

Client:	TDX Construction Corp.	Lab #:	Pending
Project:	Baruch College - Site B	Report #:	ML-01
Address:	55 Lexington Avenue New York, New York	Field Visit Date:	03/04/03
Construction Type:	Terrazzo flooring system on concrete slab	Report Date:	03/05/03
		Petrographer:	J. Walsh
		Page 1 of 10

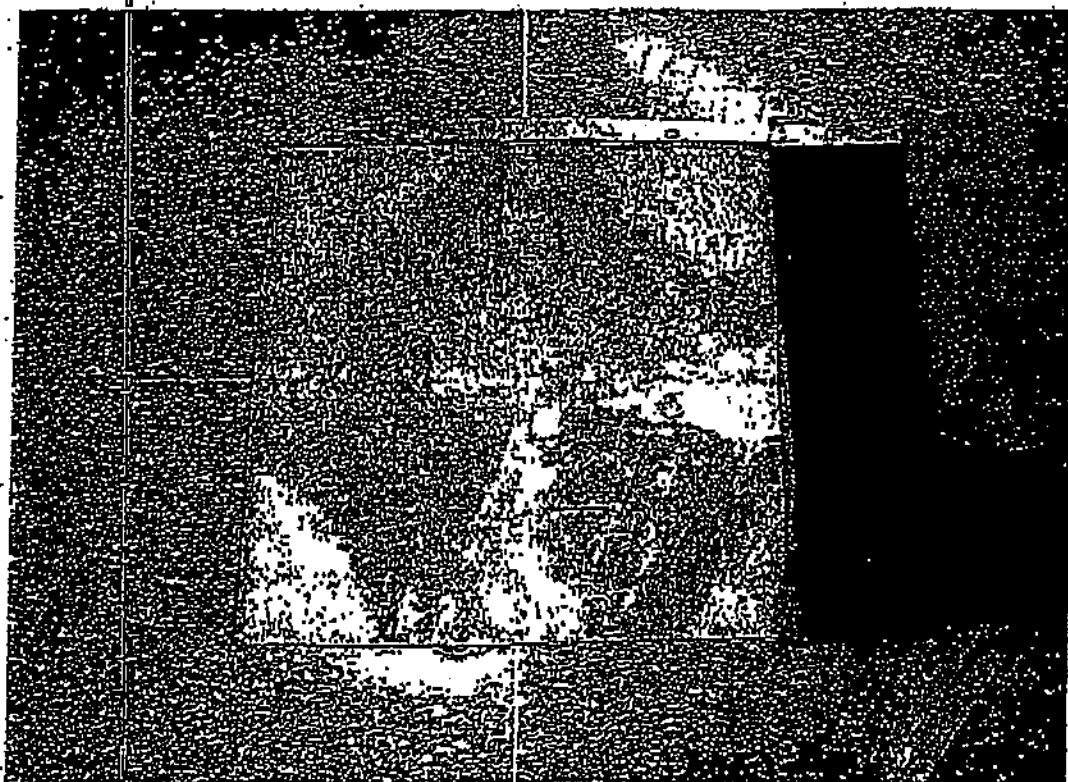
- 8) Probe 2W exposes a section centered on a corner of four terrazzo segments. The original debonding (as opposed to that created by the sample removal) is clearly defined as a rounded cross. This indicates a regular ovate pattern of failure.

Figure 2: Probe location 2W. The location intersects the corners of four terrazzo segments. The dark rounded cross reflects where the epoxy debonded cleanly from the substrate. The lighter areas reflect "rip-ups" during sampling. The debonding pattern is consistent with that related to shrinkage.

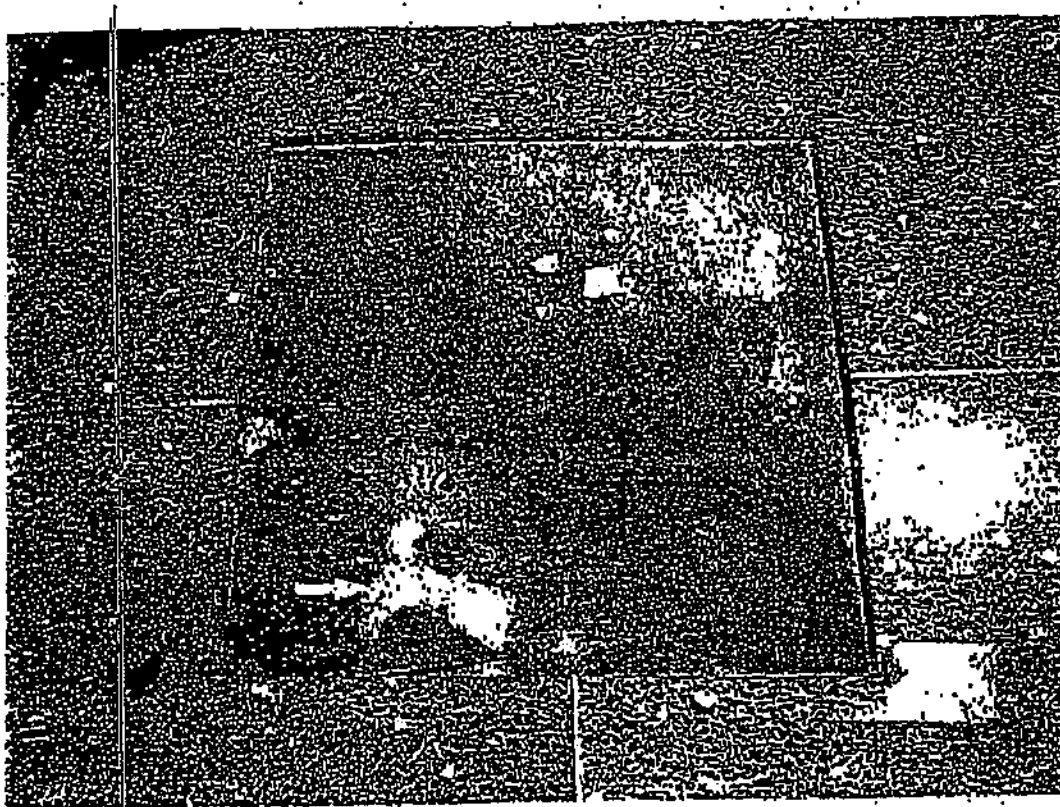
- 11) Some indication of failure between the slab and self-leveling flooring bond is noted. This is evidenced by clean separations at probe locations 7 and 12. Probe B-1 exposes a four corner contact. Sounding of the substrate revealed a debonding of the Conflow only below one corner of the four terrazzo segments. Samples of the debonded Conflow were recovered freshly from the substrate.

Figure 5: Probe location B1. The epoxy membrane is completely debonded from the smooth self-leveling compound surface. In the lower left quadrant (arrow), the self-leveling compound is clearly debonded from the concrete substrate. Sounding indicates that the debonding is present nearly everywhere below that one corner.
